Onze Molen, Durbanville

Report on Restoration Work

February 2011

2 SNAG LIST

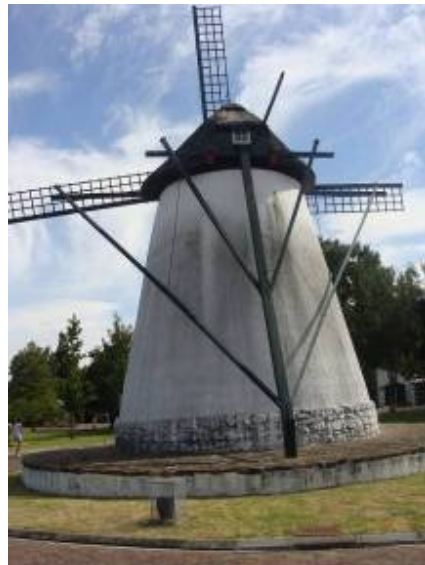
1. Lime-washing the exterior walls

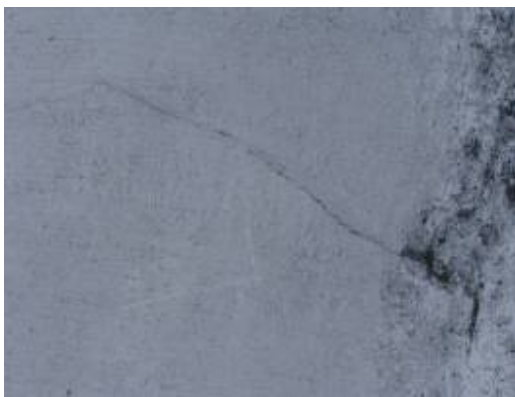
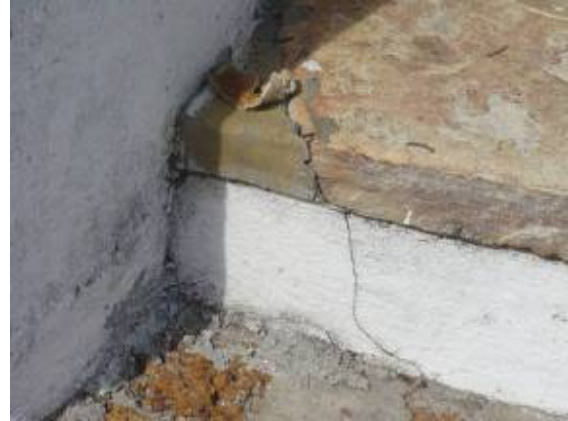
2. Repair hairline cracks which have formed in the walls and the structural cracks in the platform base and steps.
